THE SEVERE DUTY VEGETATION SHREDDER TECHNICAL TESTING OF CAPABILITY MAY 2002

Severe Duty Vegetation Shredder Technical Test

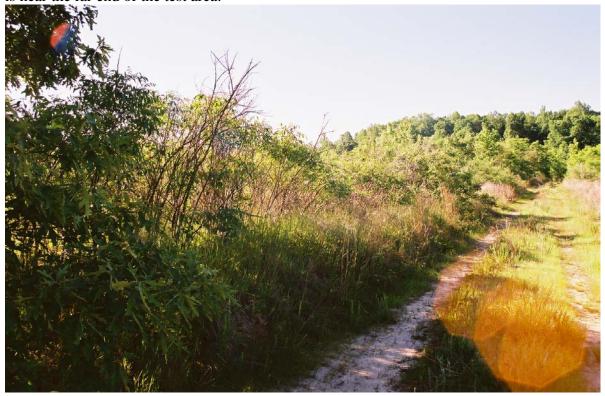
Figure 9 Category 4 Vegetation Before Shredding

The final vegetation category in which the shredder was operated consisted of a mix of dense brush with trees ranging in diameter from 10-25 centimeters and up to 10 meters high. Figure 9 shows the test area before the shredding took place. Most of the dense tree growth in the figure is near the far end of the test area.

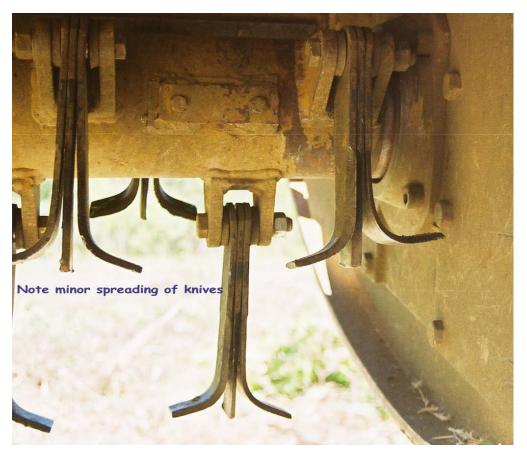
Figure 18 Knives Wear at Test Conclusion

Trees in the range of 20-25 centimeters could also be brought down, but the strain on the system was heavy and large residue is likely. After two hours of operation in this category 3 and 4 vegetation, the shredder knives were examined. Two were heavily bent but still in place and contributing to the shredding action. All knives showed evidence of minimal wear. At one point in the testing a barbed wire coil became tangled in the shredder. The after action photo is shown in figure 11. Half way down the cleared land on the left is a protrusion of uncleared bush surrounding the remaining barbed wire fence protruding into the now cleared area.

The D7 is supportable worldwide. The shredder and hydraulic portions of the system are constructed of standard components and are supportable. Most items unique to the shredder are field repairable. Daily maintenance on the SDVS required less than 30 minutes to accomplish. During the conduct of the test, two repairs were required on the D7 tractor, 1 repair on the hydraulic power supply, and none on the shredding implement and mainframe. The tractor repairs were unrelated to the SDVS system. The hydraulic power supply hydraulic thermostat did fail and was bypassed for the duration of the test. The only operational problem occurred when the shredding implement encountered and tangled a wire fence. Approximately 45 minutes and heavy wire cutters were required to unwrap the cutting drum. Wear from category 1, 2, and 3 vegetation is expected to be slow and knives may be expected to last hundreds of hours. Wear in the areas containing thick hard wooded trees was heavy and knives may need replacement every 1 or 2 days. Minor spreading and bending of some of the knives required them to be

replaced at the test conclusion, see figure 18. The manufacturer provided an Operation and Maintenance Manual which is comprehensive and well written.
